UNITED STATES ENVIRONMENTAL PROTECTION AGENCY
ENVIRONMENTAL RESPONSE TEAM CENTER
Edison, New Jersey 837

SUBJECT: South Central Terminal, Pana, Illinois

The purpose of the work assignment was for the Response Engineering and Analytical Contract (REAC) to provide technical assistance to the U.S. EPA/ERTC for on-site sampling of tanks, drums, transformers, and other vessels at the South Central Terminal site in Pana, Illinois. In addition, 21 bulk asbestos samples were taken from several on-site locations. Hazardous Categorization (HazCat) was performed on all samples collected. Samples are currently being analyzed by REAC laboratories and a subcontracted laboratory for volatile organic compounds (VOCs), total petroleum hydrocarbons (TPH), total organic halogen (TOX), TAL metals, polychlorinated biphenols (PCBs), british thermal units (BTU), sulfides, ammonia, and asbestos content. Data generated from this assignment will be reviewed and validated using REAC/ERTC data validation guidelines and procedures.

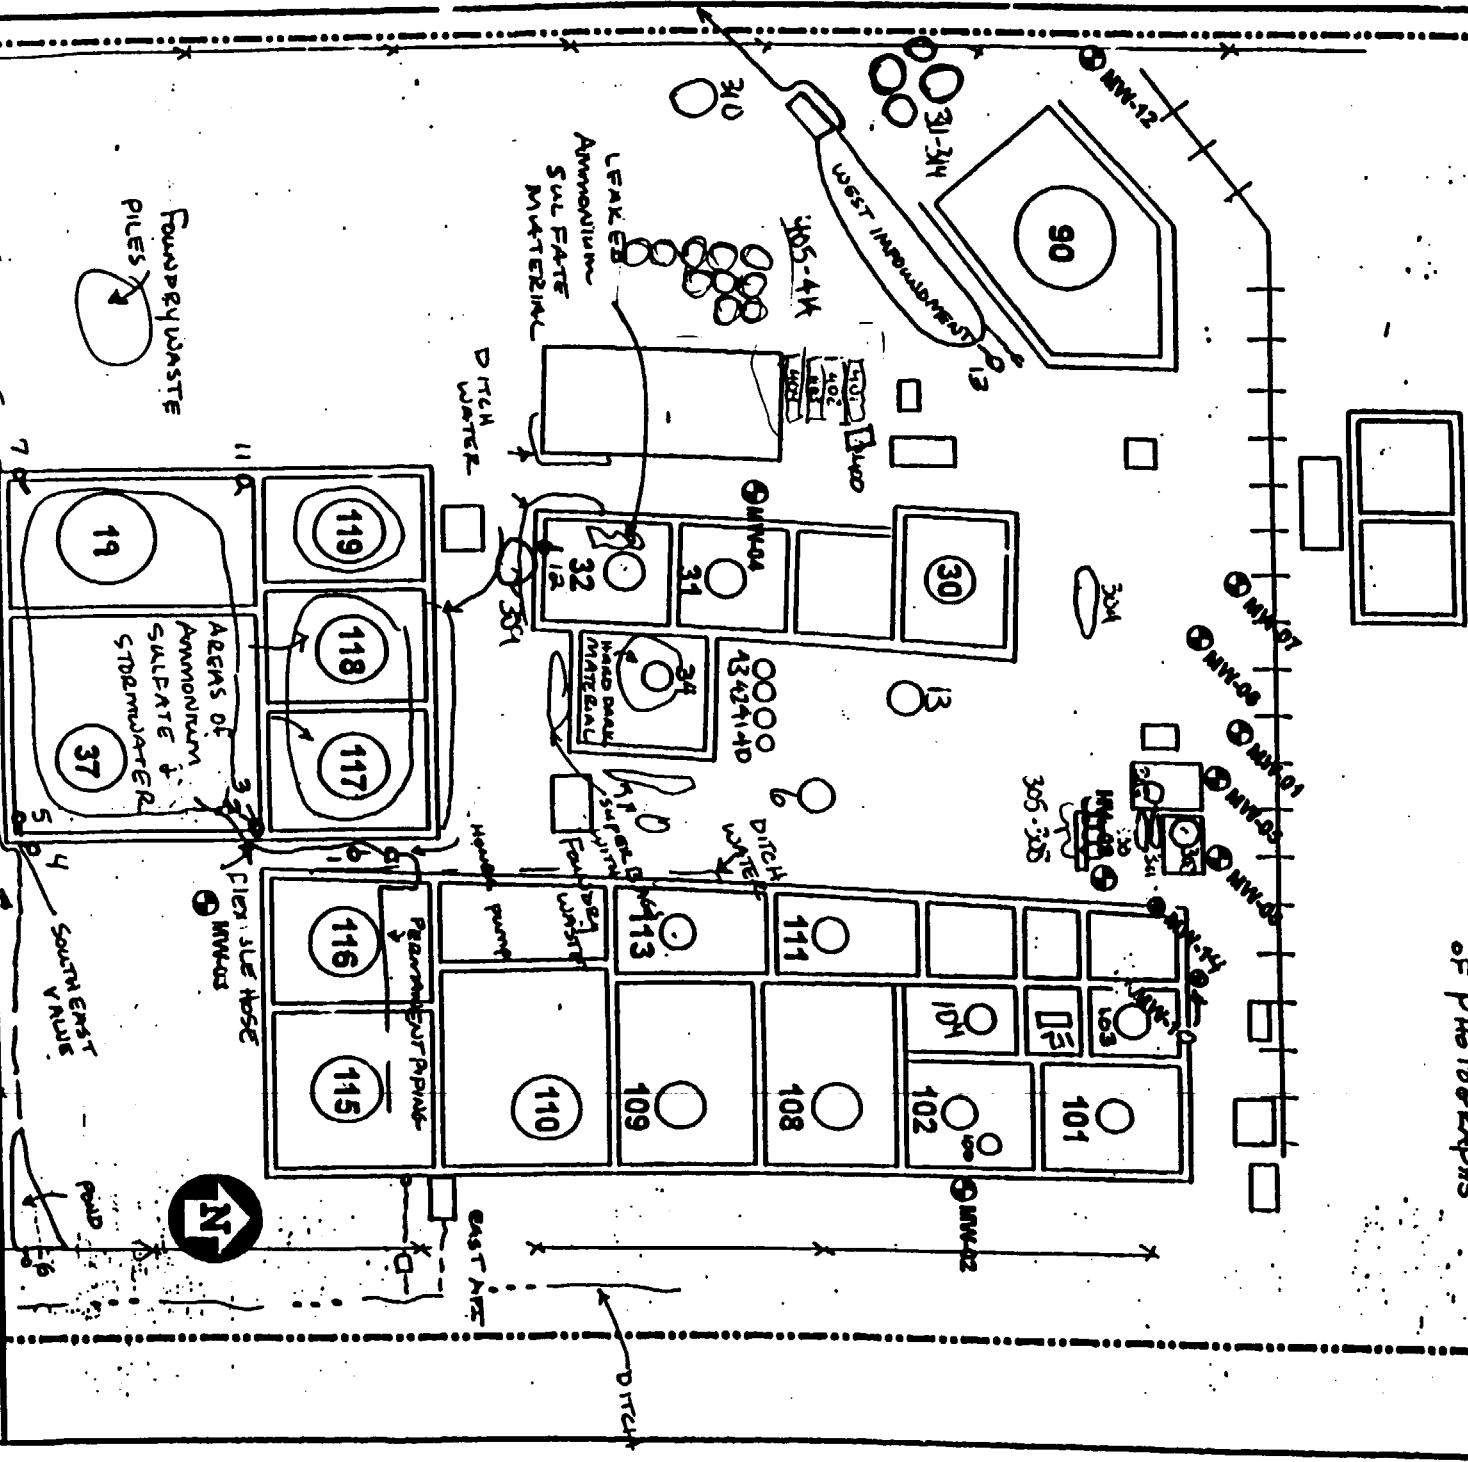
SITE SKETCH 2

Key:
b - INDICATES DIRECTION + location
OF PHOTOGRAPHS

SEE SKETCH 2 FOR FURTHER DEPICTION

ARMOR SHIELD OF ILLINOIS P.O. BOX 1225 213 E 3RD STREET CENTRALIA, IL 62801 (618)533-5963 (618)533-6964 FAX		FIGURE 2 SITE MAP		DATE: 9-24-98	
PANA REFINERY PANA, IL		JOB #		ASS8002
